Manhole Inspection Summary

Manhole # S04EE2021MH

Insp Date: **9/21/06 2:59 PM**

Location Address: **3407 OLYMPIA AVE**

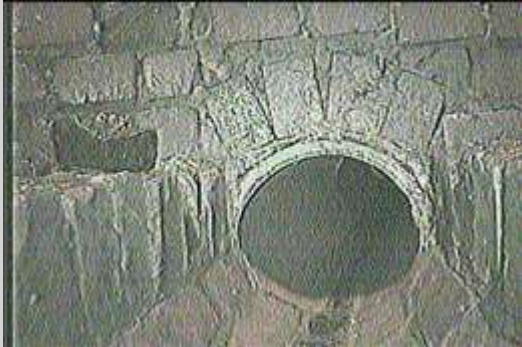
8 in. Circular Gravity Sewer
Pipe Out @ 12 O'Clock

Pipe Material: **Clay** ☐ Pipe Lined

Invert Depth: **12.95** (ft.) Flow Characteristics: **Slow**

Infiltration: **None** Pipe Seal Cond: **Unknown**
